Eco-Signs

RUBBER-SIGN PILOT PROJECT PRODUCT REVIEW: ECO-SIGNS

Doc No: // Authors: JC van der Walt
Revision: 1 // Date: 3 June 2020

SANRAL

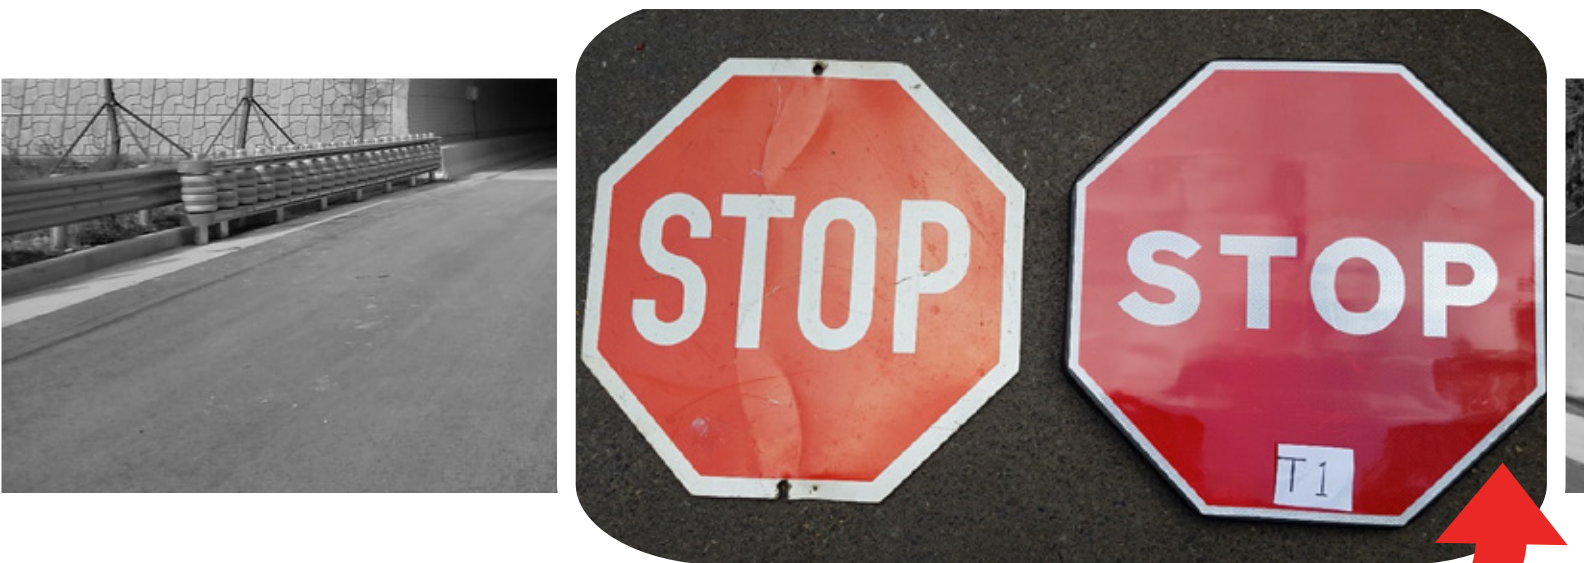
Figure 1: Compliant sign on the left, sample rubber sign on the right.

The samples of the signs provided however did not comply with the South African Road Traffic Sign Manual (SARTSM), i.e. the regulatory stop sign lettering dimensions were only 115mm instead of 210mm for a 60 km/h restriction, but the other dimensions of the frame did comply. For comparison of the rubber sign letter dimensions with that of a compliant sign see Figure 1 below.

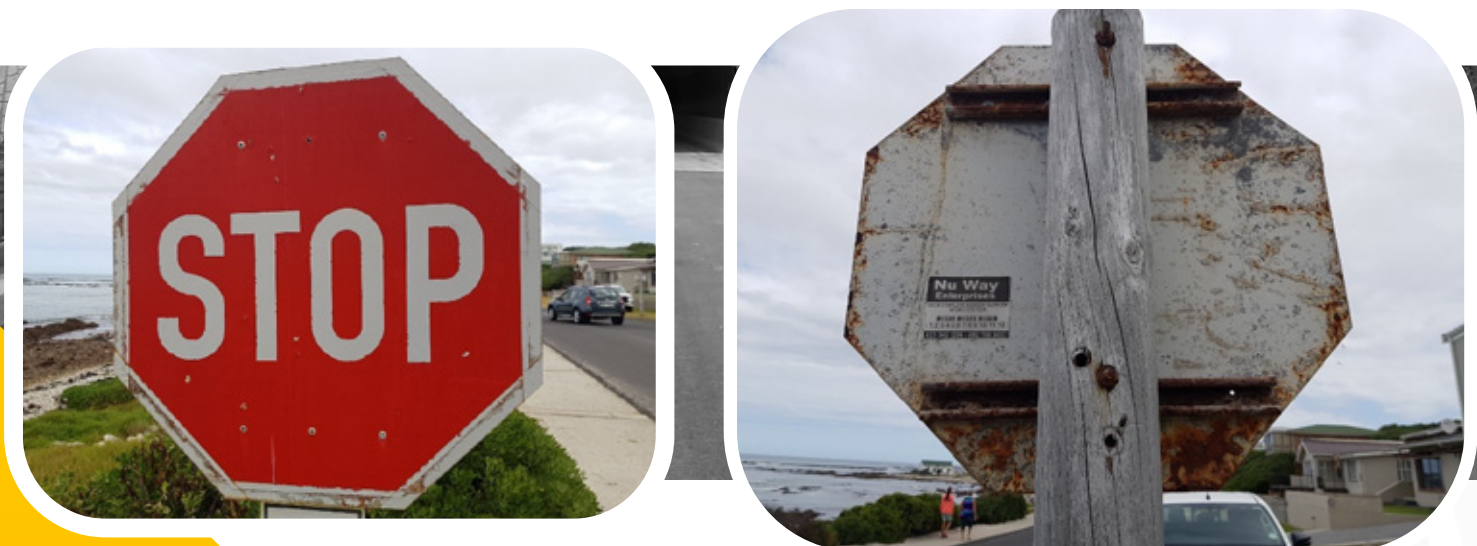
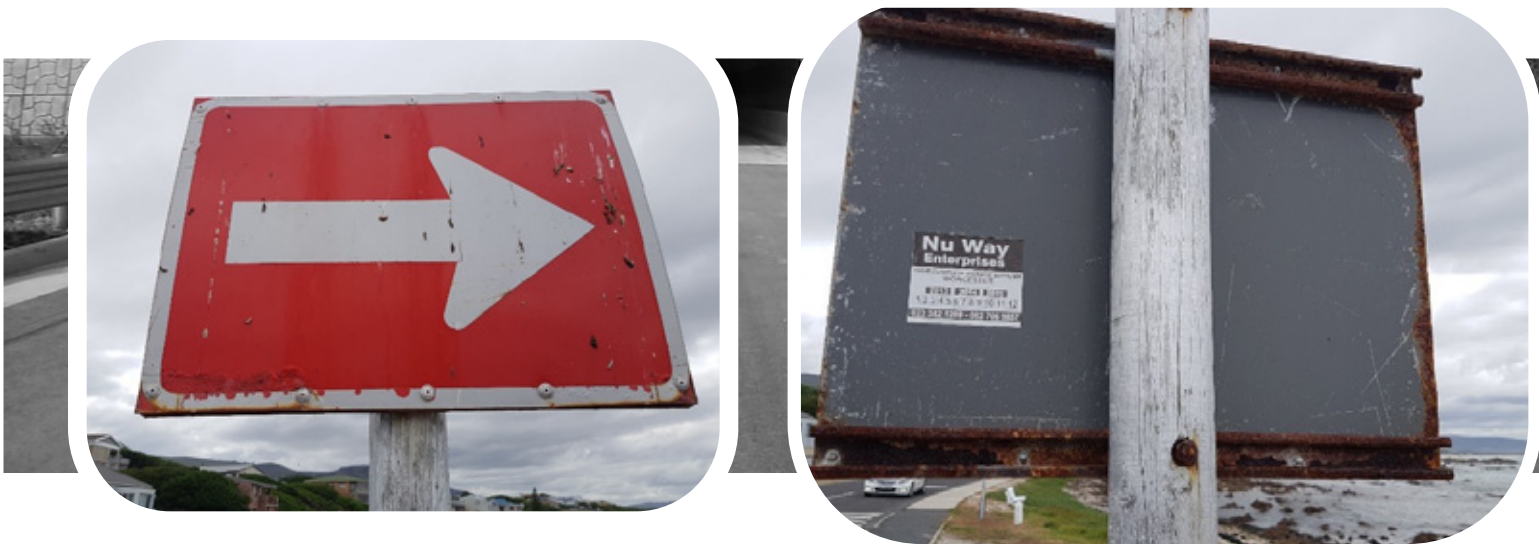
Figure 4 below shows the effect of erosion of the road signs that were erected in 2013, the photos were taken in 2020, thus 7 years. The signs were exposed to coastal conditions for this period. Corrosions is visible on the signs despite being made from galvanized plates.

Figure 4: Condition of galvanized signs exposed to coastal conditions.

The road traffic signs used by the municipalities are mostly manufactured from Chromadek sheets which despite being galvanised corrode with time and does not last as long as the inland traffic signs and therefore require more frequent replacement. In contrast, rubber road traffic signs do not contain any metal as part of the sign except for the bracket which is used to mount the sign to a pole. If stainless steel brackets are used it will contain no elements/part that can erode.

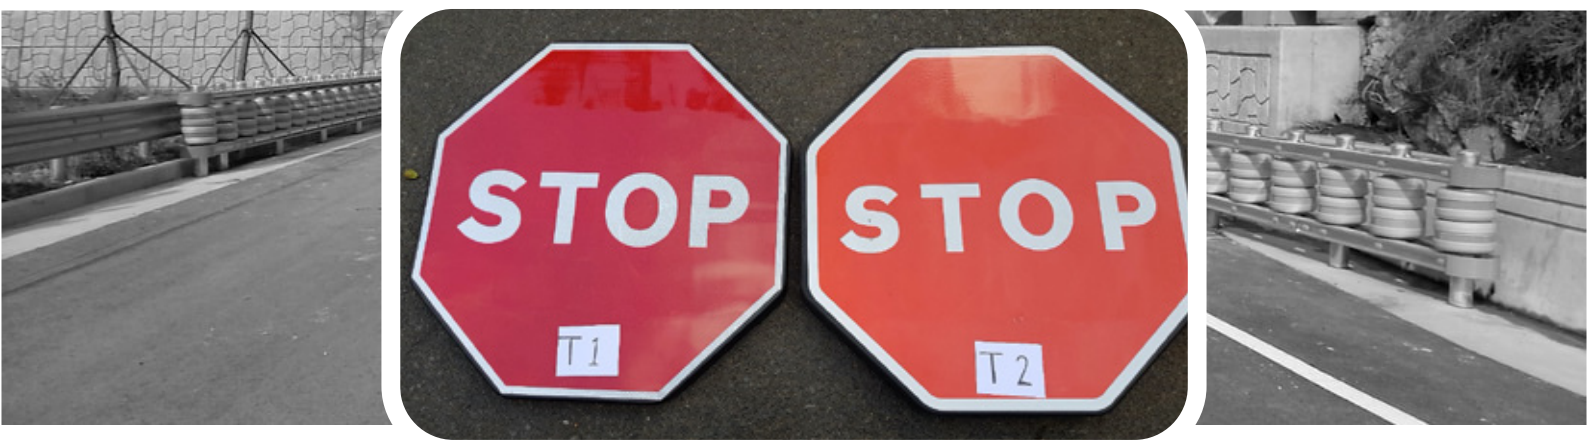
We compared the degradation of the rubber signs (mould samples T2 and T3) placed in the sun for 6 months with a mould sample (T1) which was kept out of the sun and environment over the same period as shown in Figure 5.

Figure 5: Degradation of rubber signs with different class retroreflective material.

The difference in colour between T1 and T2 is related to the difference in classes of the retroreflective material and not to UV degradation.

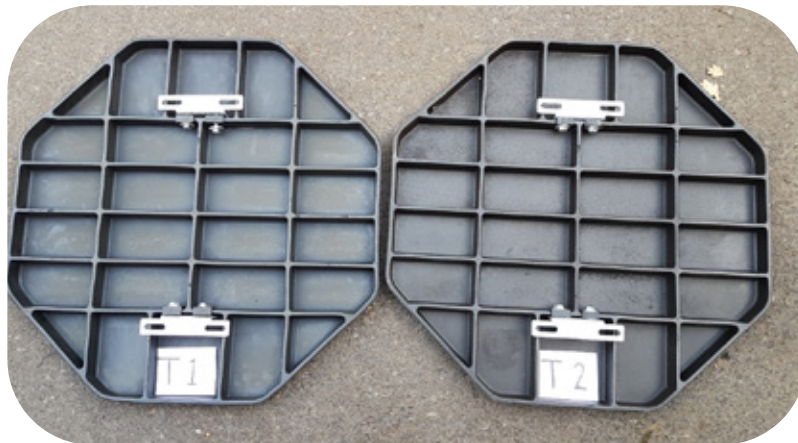
We could not observe any fading of the rubber moulds, changes in colour, loss of strength, premature cracking or disintegration of the rubber moulds. See photos of rubber mould samples T1, T2 and T3 in **Figure 6** and **Figure 7** respectively.

Figure 6: Photos of the backside of the rubber sign moulds T1 and T2.

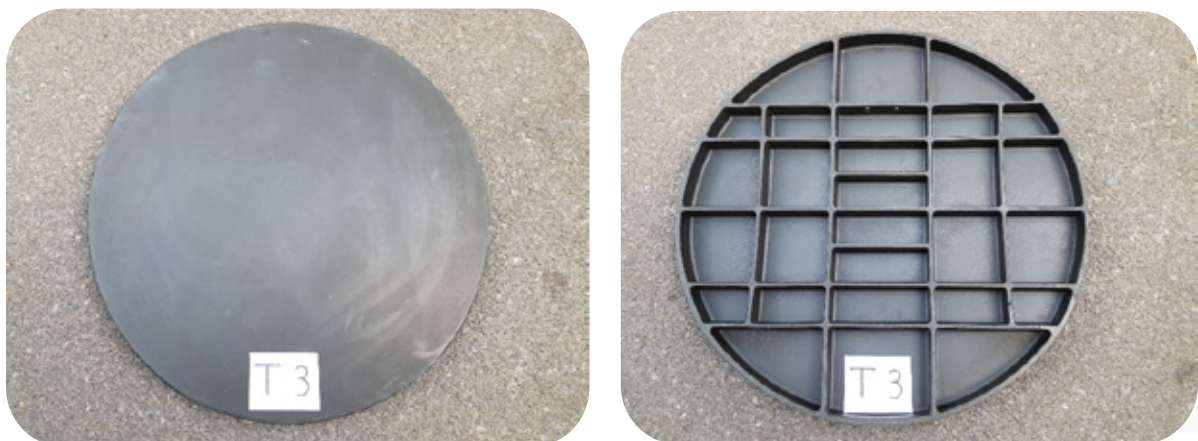
Figure 7: Photos of the front and backside of the rubber sign mould.

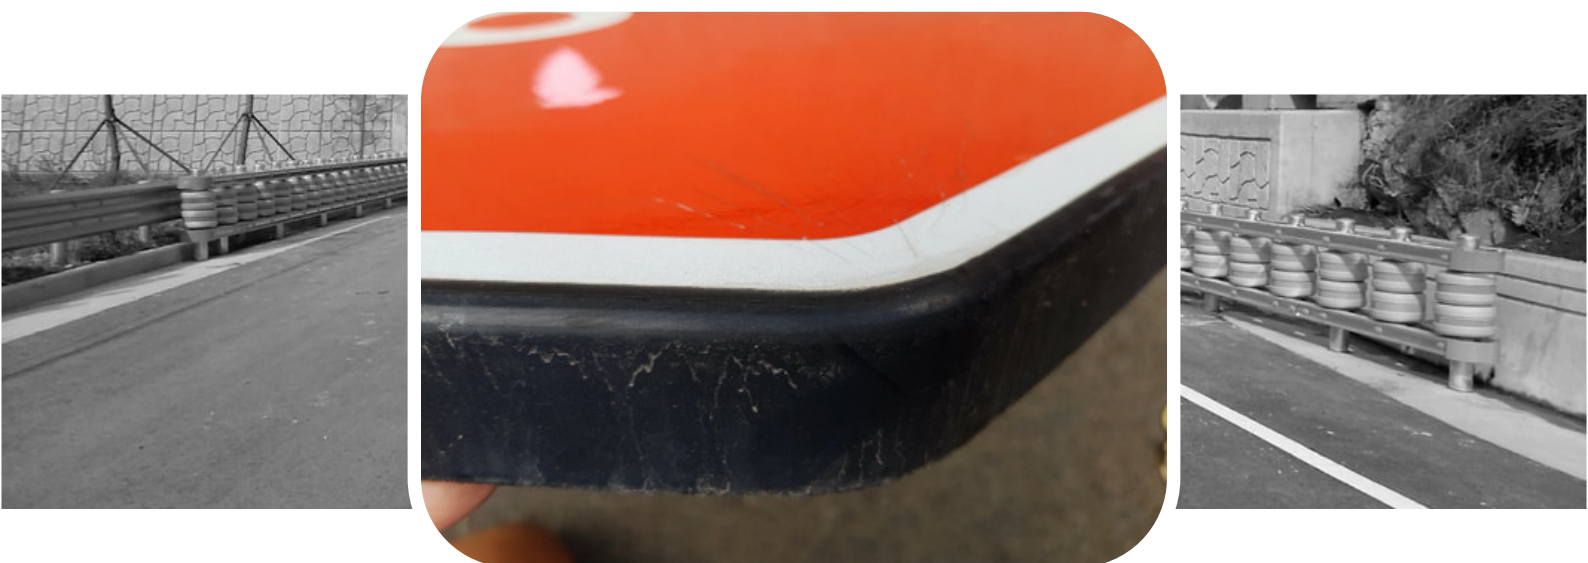
No clear evidence of delamination could be found after the pilot duration as shown in Figure 8.

Figure 8: Photo of the delamination inspection between the retroreflective material and the rubber mould. No delamination was observed after 6 months.

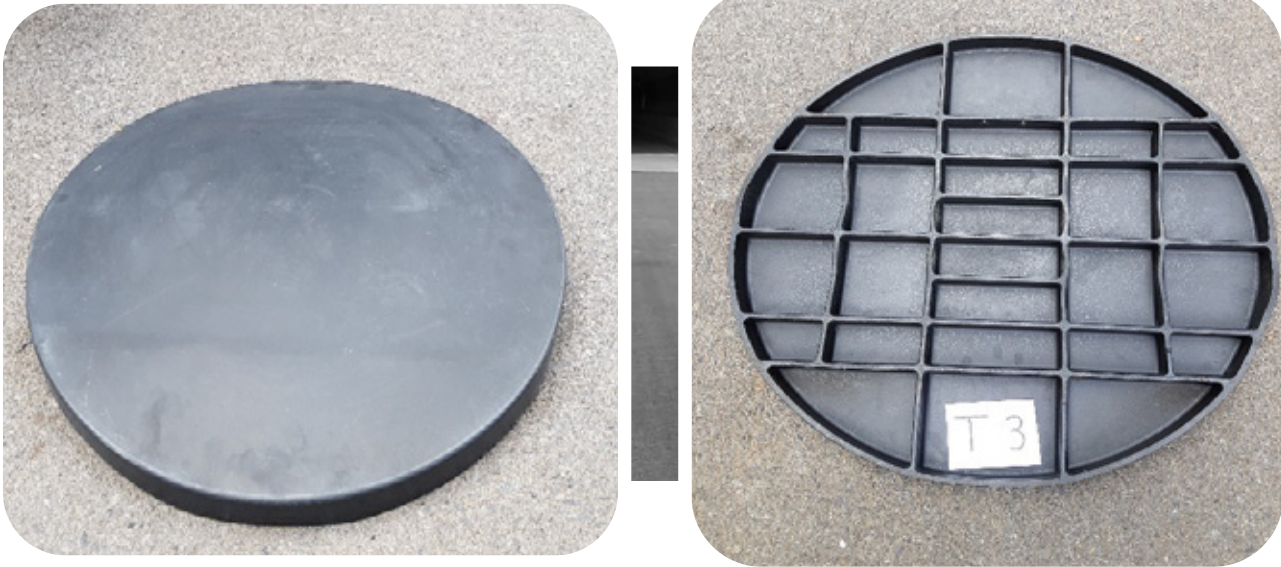
Mould sample T3 was used to test the temporary bending properties of the rubber moulds. Pressure was applied to the mould until the two outer edges of the mould touched and then released to see how quickly it goes back to its original shape as shown in **Figure 9**. After releasing the pressure, the rubber mould retracted to its original shape shown in **Figure 10**.

Figure 10: Photos of retracted rubber sign after bending

What the bending test has shown is that the rubber signs will retract to their original shape after bending. We also found that it is very difficult to bend the rubber signs once they have been fixed to a signpost

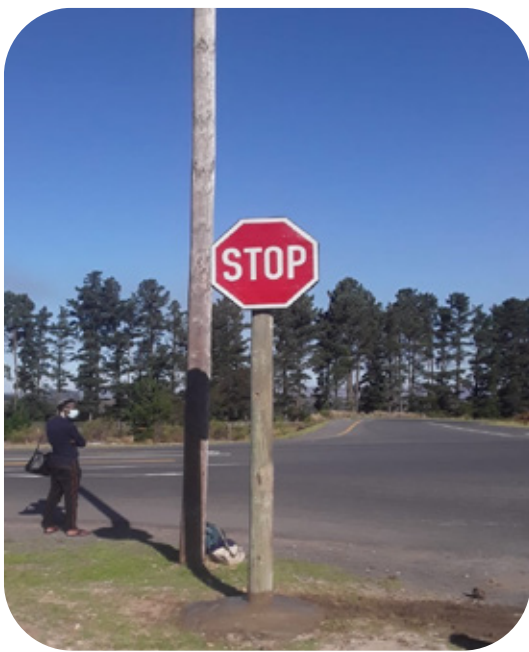
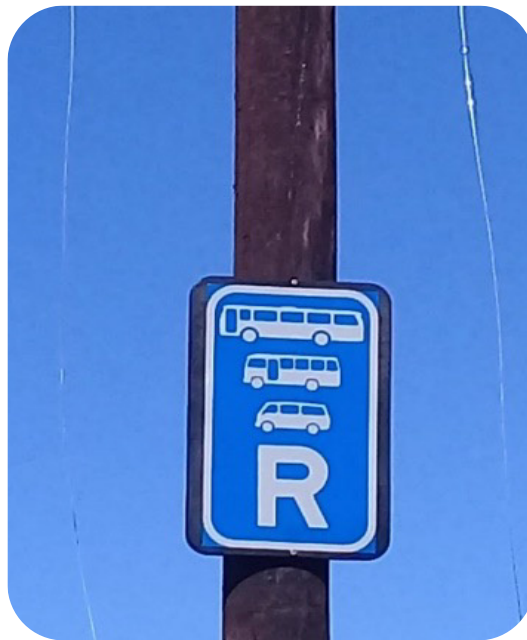
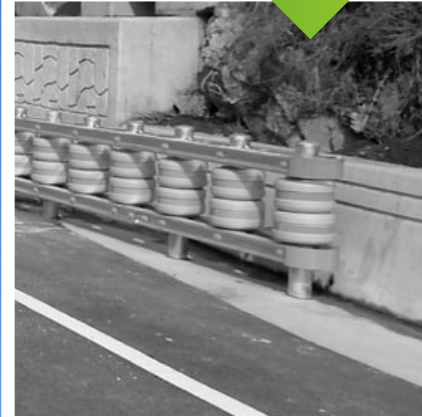
Although the signs have been erected in a high-risk area for vandalism and theft they were not removed or vandalised during the pilot project. The fact that the rubber Stop R1 sign was fixed higher than the normal distance above ground level could also have contributed to it not being vandalised. See photos of the signs taken at end of May 2020 shown in **Figure 11**.

Figure 11: Photos of rubber signs at end of May 2020.

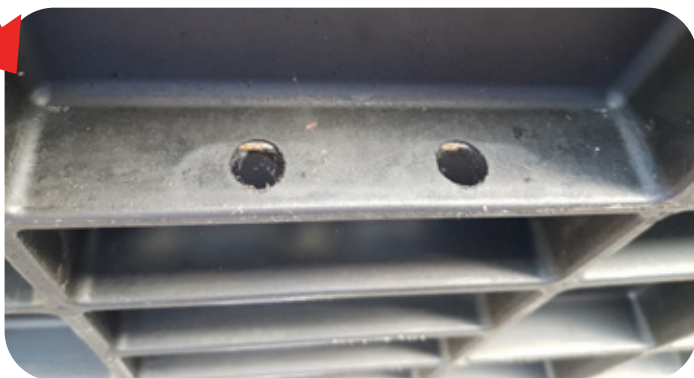
The rubber signs are provided with two special brackets for the fixing of the signs to signposts. These brackets are fixed to the rubber mould through holes in the rubber mould ribs/stabilizers as shown in **Figure 12**. The holes for the brackets are close to the edge of the ribs and U shape fibreglass elements are used to strengthen the fixing of the rubber mould with the bracket as shown in **Figure 13**. The brackets fixed to the sign are shown in **Figure 14** and the fixing of the sign to a timber post using the brackets and sanky clamps is shown in **Figure 15**.

Figure 12: Holes in the rubber sign mould for the fixing of brackets.

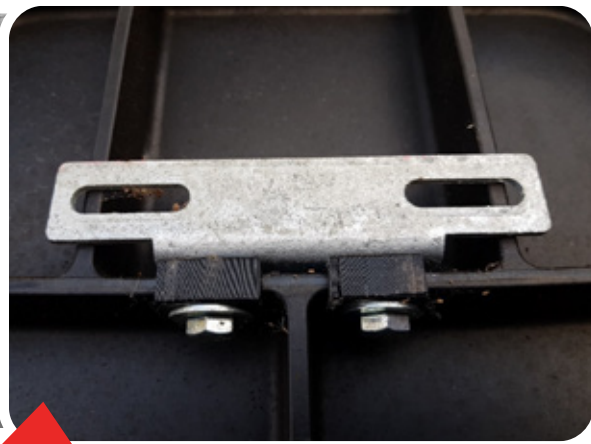
Figure 14: Photo of the fixed bracket

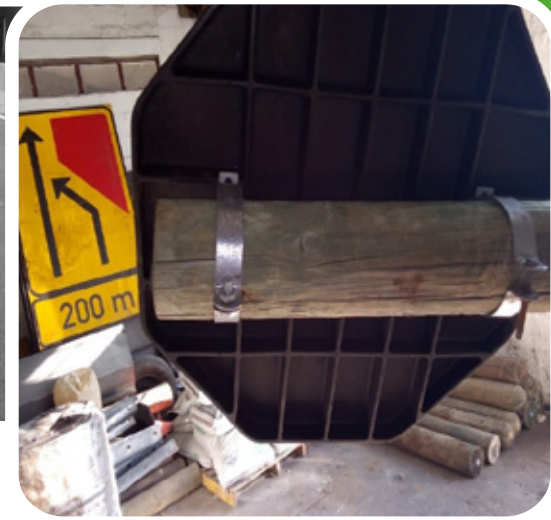
Figure 15: Used sanky clamp system to fix rubber sign to timber post.
